CHAPTER 2

DISCOVERY

## FACILITIES ASSESSMENT SUMMARIES

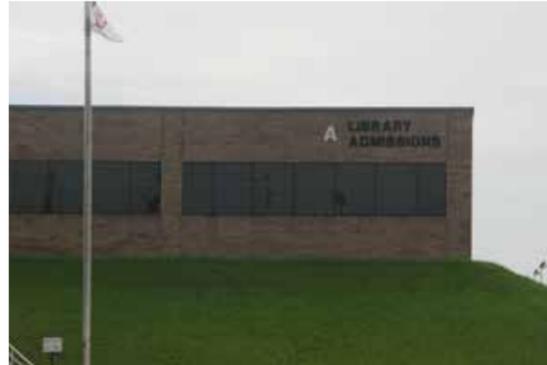
- Upgrading the restrooms, including meeting ADA criteria.
- Upgrading from single-pane to double pane glazing.
- Repair or replacement of the aluminum stair rails and guard rails.

- The elevator is 40 years old and will eventually become impractical to maintain. Replacement should be considered within the next 3-4 years to ensure continuing service. Enlarging the elevator for additional freight capacity is likely not practical, but should be evaluated.

- Consideration should be given to upgrading all exterior door locking devices to key-card access for increased security and convenience.
- The roof is generally in good condition and with continued routine maintenance should remain serviceable for several years.

- Consider replacement of exposed aggregate paving at first and second floor arcades and breezeways, and at stair treads.
- Consider installation of fire sprinkler system.

- Replacement of cast iron sanitary piping.
- Replacement of the two air handling units.
- Replacement of original variable air volume distribution units.

- Replacement of original pneumatic HVAC controls with new direct digital controls.
- Repair outside air intake system to original designed function.
- Install automatic controls on exhaust fans.

- Install sump pump in elevator pit.
- Reroute sanitary drain piping in first floor break-room (cannot run to vent piping).
- Replace failing lighting control contactors and controls.

- Install exhaust fans for custodial rooms.
- Repair subsurface drainage piping system at exterior walls.
- Upgrade lighting at exterior stairs.
- Perform infrared survey of electrical gear.

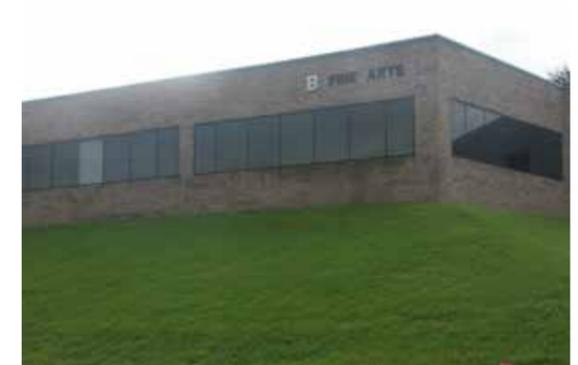
- Upgrading the restrooms, including meeting ADA criteria.
- Upgrading from single-pane to double pane glazing.
- Repair or replacement of the aluminum stair rails and guard rails.

- Consideration should be given to upgrading all exterior door locking devices to key-card access for increased security and convenience.
- The roof is generally in good condition and with continued routine maintenance should remain serviceable for several years.

- Consider replacement of exposed aggregate paving at first and second floor arcades and breezeways, and at stair treads.
- Consider installation of fire sprinkler system.

- Address moisture encroachment from high earthen berms.
- Address noise transmission issues from orchestra/band hall to adjacent spaces.
- Inspect and make operable the smoke relief hatches over the auditorium stage.

- Replacement of air handling unit #5 above the stage.
- Replacement of original variable air volume distribution units.
- Replacement of cast iron sanitary piping.

- Replacement of halogen house lighting in the auditorium.
- Replacement of failing lighting control contactors and controls.
- Address infiltration of moisture at exterior walls covered by the earthen berms. Repair subsurface drainage piping system at exterior walls.

- Repair outside air intake system to original designed function.
- Install automatic controls on exhaust fans.
- Install exhaust fans for custodial rooms.

- Replace failing plumbing isolation valves.
- Upgrade lighting at exterior stairs.
- Perform infrared survey of electrical gear.
- Perform an air/water balance survey for detailed account of the performance of fans and coils.

- Replace the original drinking fountains.
- Perform a breaker coordination study and adjust/replace breakers that are tripping mains.
- Perform testing of all emergency lighting including egress lighting and exit signs.

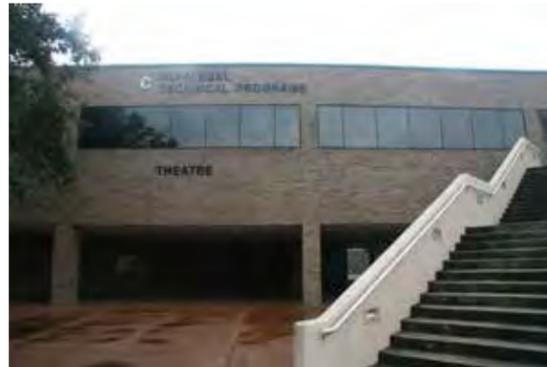
- Upgrading the restrooms, including meeting ADA criteria.
- Upgrading from single-pane to double pane glazing.
- Repair or replacement of the aluminum stair and guard rails.

- Repair or replacement to exterior steel doors that bind.
- The breezeway elevator is 40-years old and will eventually become impractical to maintain. Replacement should be considered within the next 3-4 years to ensure continuing service. Enlarging the elevator for additional freight capacity is likely not practical, but should be evaluated.

- Consideration should be given to upgrading all exterior door locking devices to key-card access for increased security and convenience.
- The roof is generally in good condition, but a few deficiencies need to be addressed. With continued routine maintenance the roof should remain serviceable for several years.

- Consider replacement of exposed aggregate paving at first and second floor arcades and breezeways, and at stair treads.
- Consider installation of fire sprinkler system.

- Address moisture encroachment from high earthen berms.
- Repair access holes in exterior walls above plaster soffit.
- Provide air balancing to improve distribution within the building.

- Repair outside air intake system to original designed function.
- Replacement of original variable air volume distribution units.
- Replacement of air handling units.

- Replacement of original pneumatic HVAC controls with new direct digital controls.
- Install automatic controls on exhaust fans.
- Install sump pump in elevator pit.

- Replace failing plumbing isolation valves.
- Replace failing lighting control contactors and controls.
- Repair subsurface drainage piping system at exterior walls covered by the earthen berms to address moisture infiltration.

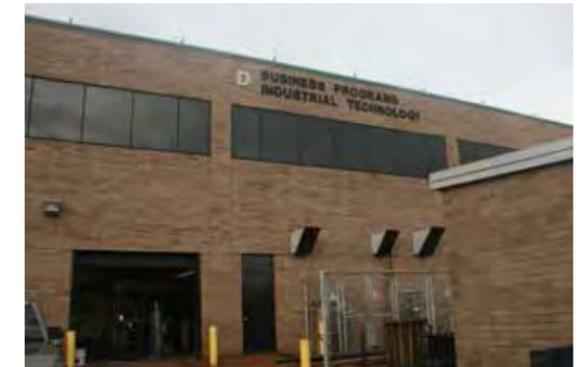
- Upgrading the exterior-access restrooms, including meeting ADA criteria.
- Upgrading second-floor interior door hardware to lever type that would be ADA-compliant.

- Replacing stained ceiling tiles and rusted ceiling grid after determining that cause of water leak has been repaired.
- Upgrading from single-pane to double pane glazing.

- Repair or replacement of the aluminum stair rails and guard rails.
- Repair or replacement to exterior steel doors that bind.
- Consideration should be given to upgrading all exterior door locking devices to key-card access for increased security and convenience.

- The roof is generally in good condition with only a couple of deficiencies that need to be addressed. With continued routine maintenance the roof should remain serviceable for several years.

- Consider replacement of exposed aggregate paving at first and second floor arcades and breezeways, and at stair treads.
- Consider installation of fire sprinkler system.

- Replacement of air handling units.
- Replacement of original variable air volume distribution units.
- Replacement of original pneumatic HVAC controls with new direct digital controls.

- Repair outside air intake system to original designed function.
- Provide ventilation for machine shop and print shop.
- Install automatic controls on exhaust fans.

- Replacement of failing lighting control contactors and controls.
- Replacement of failing plumbing isolation valves.
- Address infiltration of moisture at exterior walls covered by the earthen berms. Repair subsurface drainage piping system at exterior walls.

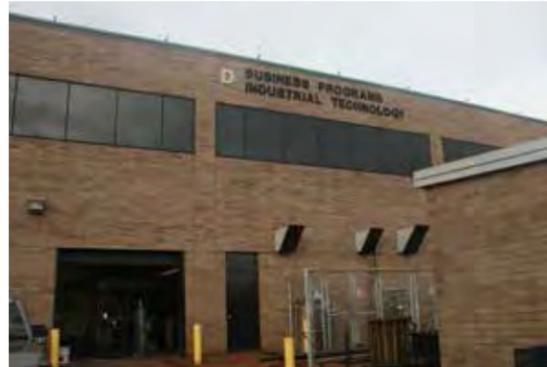
- Evaluate the exhaust system in the welding shops to verify the quantity of air removed is adequate and the make-up air system is functioning.
- Upgrade exhaust system in welding shop 2.

- Replace hot water and chilled water system pumps.
- Perform study of chilled and hot water supply loop to validate the differential pressure set-points. Rebalance the system to most efficient operation settings.

- Perform test on primary transformer and medium voltage switchgear at plant and replace as necessary.
- Upgrade electrical capacity at plant switchgear.

- Repair subsurface drainage piping system at exterior walls.
- Upgrade lighting at exterior stairs.
- Perform infrared survey of electrical gear.
- Perform an air/water balance survey for detailed account of the performance of fans and coils.

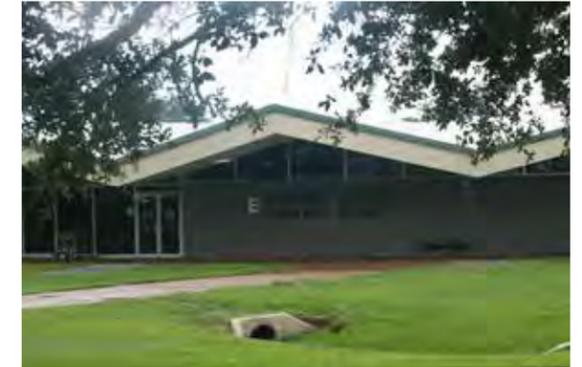
- Consider bringing all restrooms into ADA-compliance, including enlargement of kitchen restroom.
- Upgrading remaining twist-knob door hardware to lever type that would be ADA-compliant.

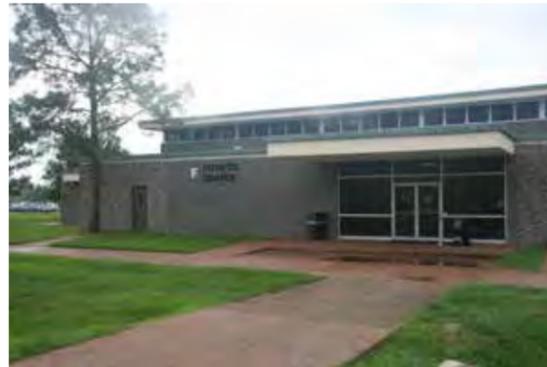
- Consider piping all roof drains and AC condensate lines to underground piping to ensure against water intrusion into the building and soft grade at building perimeter.

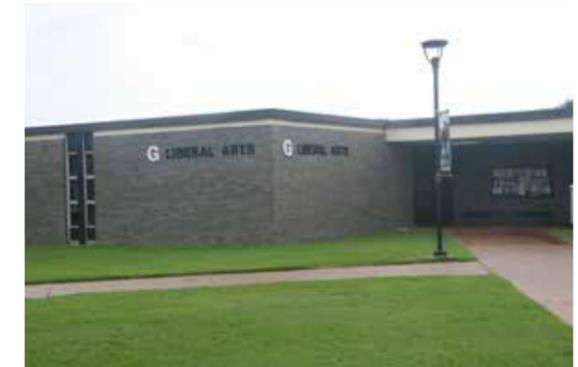
- Consider bringing all restrooms into ADA-compliance, including enlargement where necessary.
- Upgrading from single-pane to double pane glazing.
- Consider additional exit doors from the larger class-rooms and student lounge.

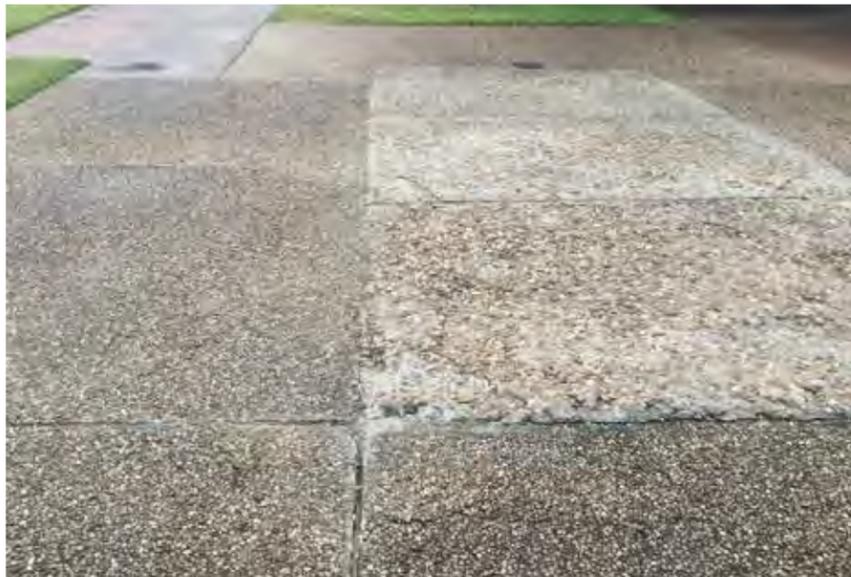
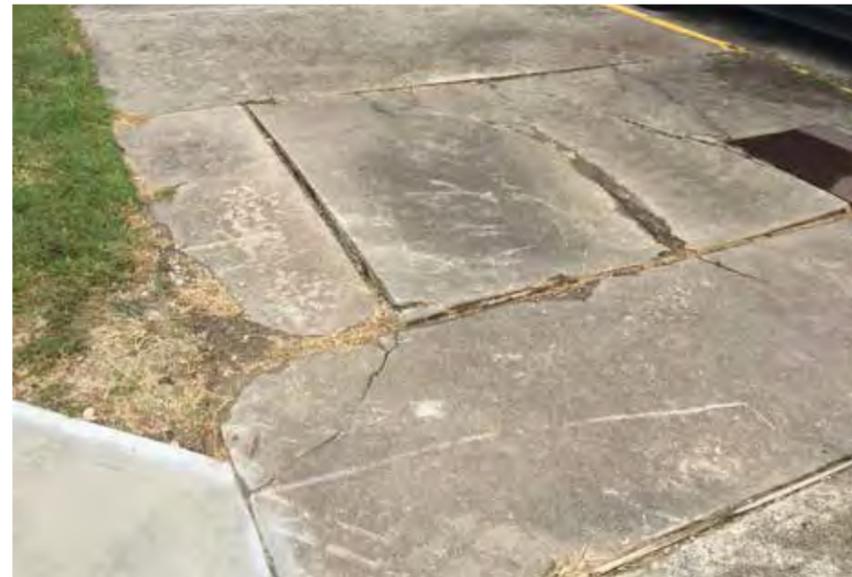
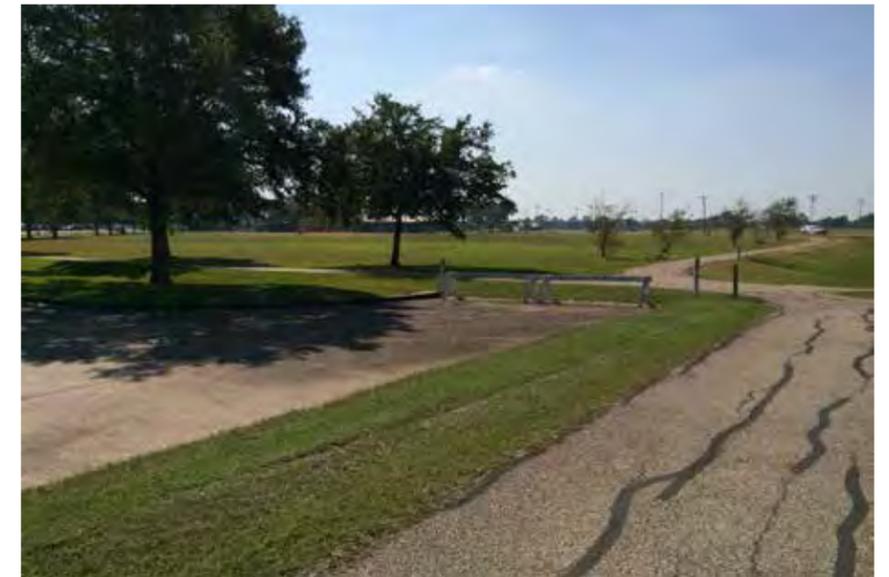
Finally, the majority of the parking areas are in need of repair. Standing water, poor drainage, and potholes increase the possibility for damage to property, vehicles, students, and employees. In order to determine the optimum repair method (i.e. Reclaiming the existing asphalt vs adding a thin seal coat) for the different affected areas, geotechnical borings should be collected in key locations.
