CHAPTER 2

DISCOVERY

## FACILITIES ASSESSMENT SUMMARIES

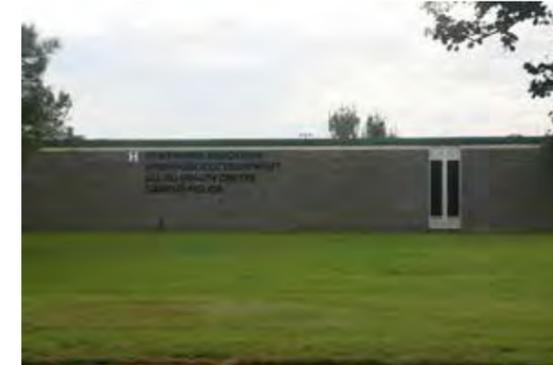
- Correct thin gravel areas on roof.
- Address recessed brick soldier course at top of exterior walls to eliminate recessed brick that likely is allowing water penetration into the walls.

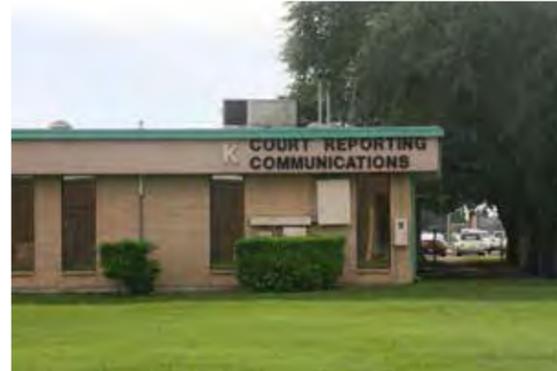
- The foundation should be stabilized before proceeding with any other repairs or upgrades:
- Make minor roofing repairs as reported.
- Make repairs to extensively cracked exterior brick.

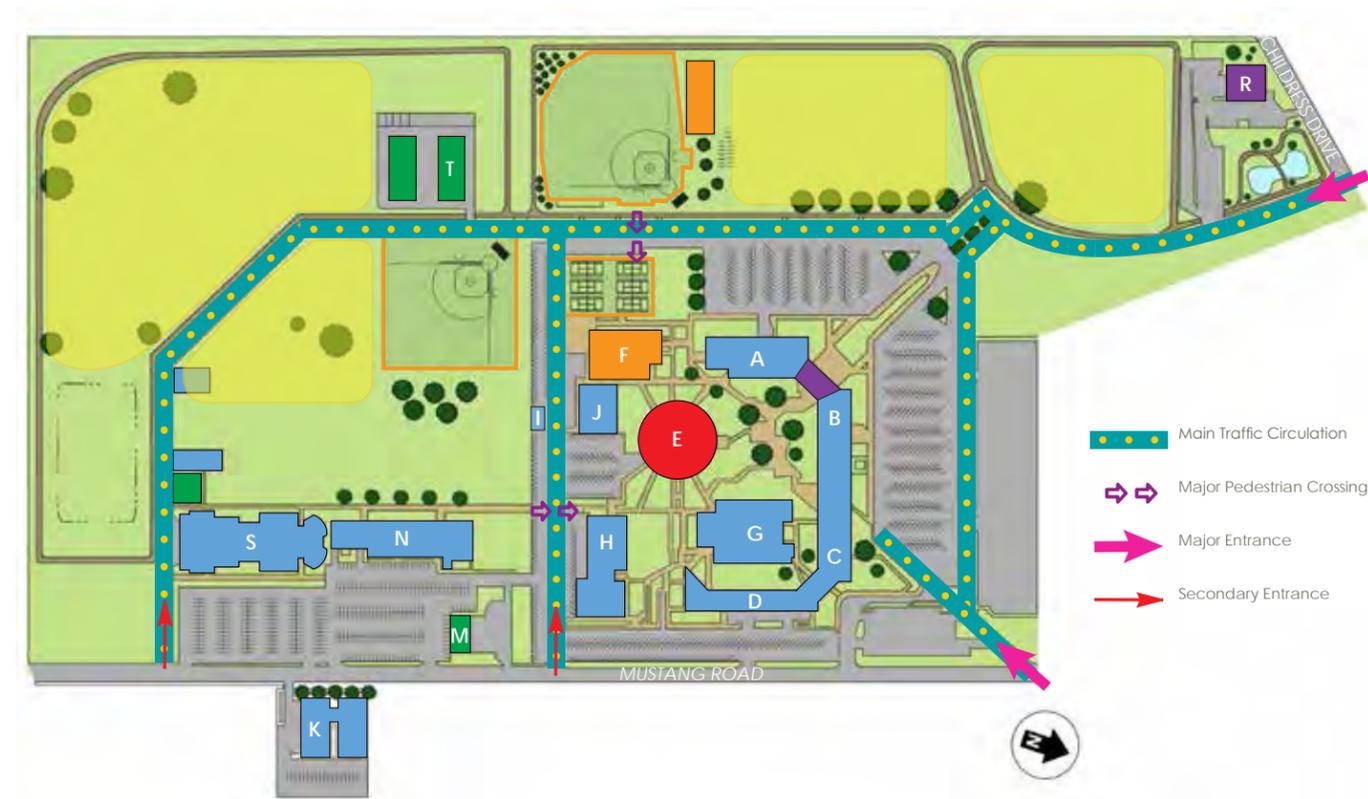
The formal entrance to Alvin Community College is from Highway 35 at Childress Drive. At this entrance there is a concrete monument sign wall, as well as a modest masonry sign structure with a digital marquee panel. However, in context with the scale, traffic, and commercial nature of the Highway 35 corridor, the presence of the college is underwhelming. The signs at this intersection lack a strong, clear sense of campus identity, which can be confusing to new arrivals to campus.

Once past the intersection the entry drive has some of the better landscaping on campus. The drive through the formal Live Oak grove, at the outer edge of the parking area, is a gateway experience that should be emphasized by reconfiguring Childress Drive to continuously flow without a stop.

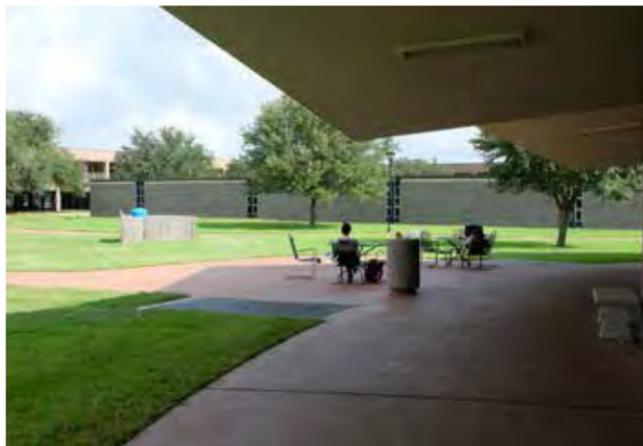
The covered walkway on the southern portion of campus distinguishes pedestrian circulation and directly serves N and S Buildings. The primary walk surface material is exposed pea gravel aggregate that has a distinctive appearance, but has proved difficult to maintain and repair over the years. There are many areas that have been patched with a very dissimilar color and texture finish. The newer walks are standard concrete with and provide a good, uniform appearance.

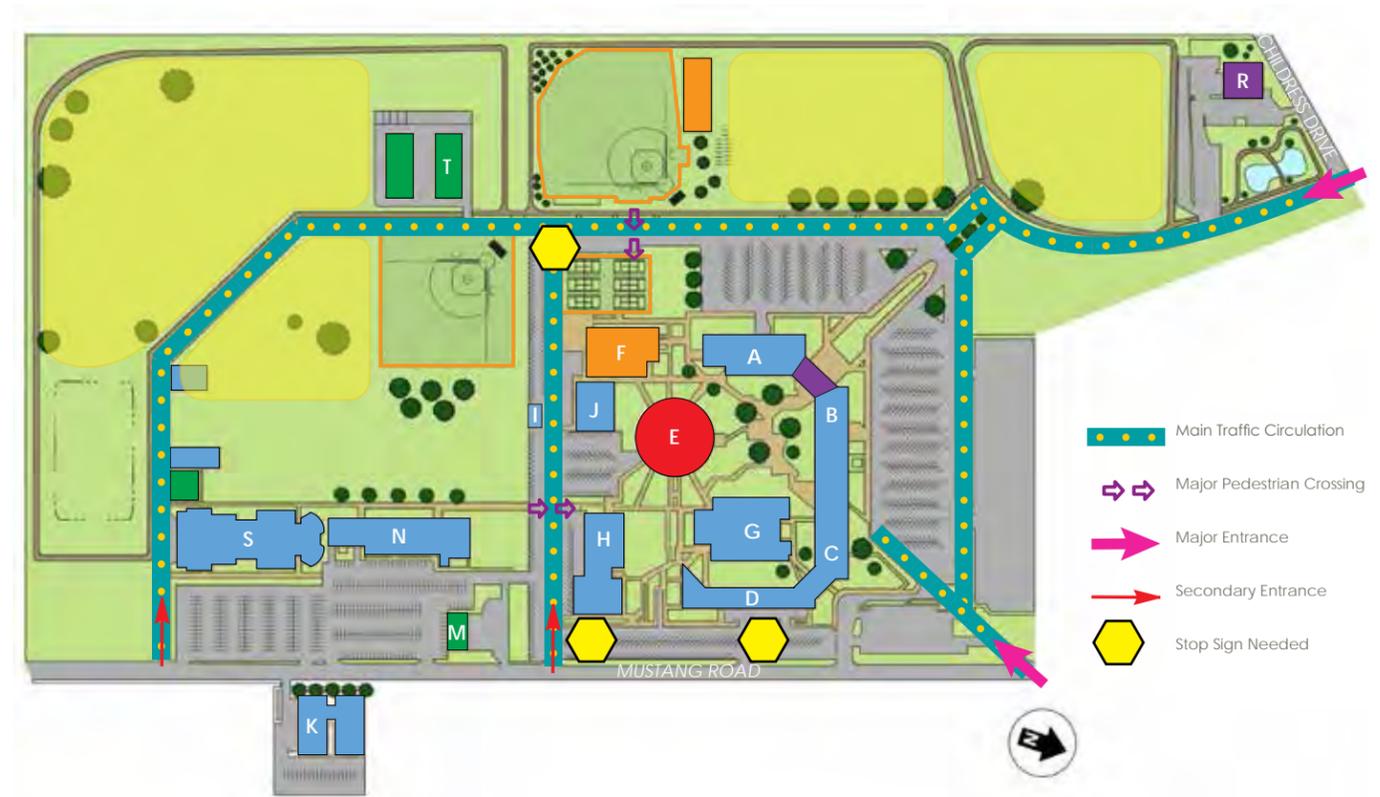
Regulatory signs throughout the campus do not meet the proper height requirements, 7 feet, listed in the Manual on Uniform Traffic Control Devices (MUTCD). The majority of regulatory signs on campus do not meet this standard, and in many instances are less than four feet above the edge of pavement. This provides advanced visibility issues with the signs due to the difficulty to see them beyond a parked vehicle or when traveling behind another vehicle. Additionally, three locations on campus where internal roadways intersect are missing stop signs and stop bars.

ACC has eight way-finding signs throughout campus (see photo at left). The way-finding signs provide adequate information to navigate to a specific building on campus. One item that should be displayed more explic-

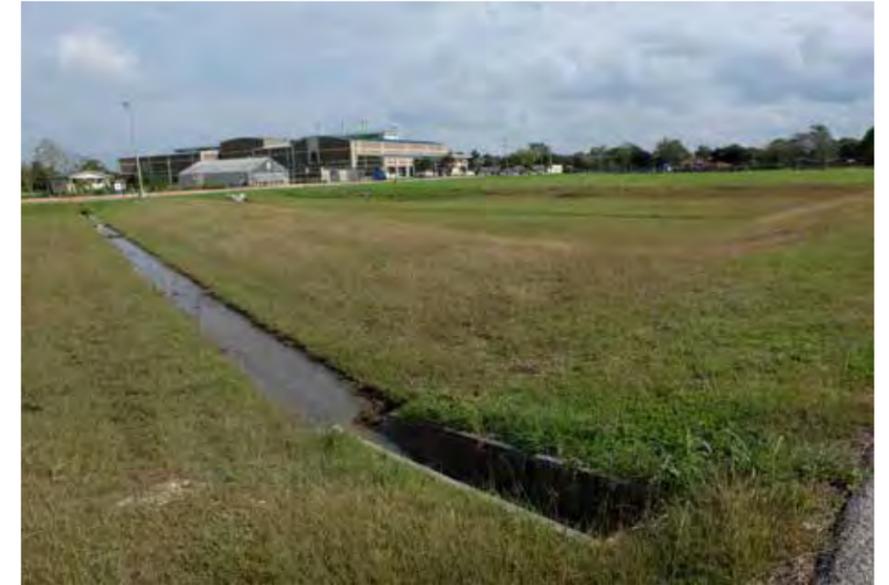
Figure 1: The detention pond and pilot channel

While portions of ACC were constructed prior to the current drainage regulations and requirements for stormwater detention, the campus does have a detention pond along the southern property boundary. This pond contains a concrete pilot channel. Upon inspection, it appears that this pilot channel is holding water instead of aiding the offsite evacuation of said water. A topographic survey should be completed for this pilot channel in order to determine the current slope and grade. It is possible that portions of the pilot channel have subsided and could be elevated to promote proper flow. However, it may also be determined that the pilot channel needs to be removed and replaced with a new pilot channel. This decision can be made after the survey has been completed.

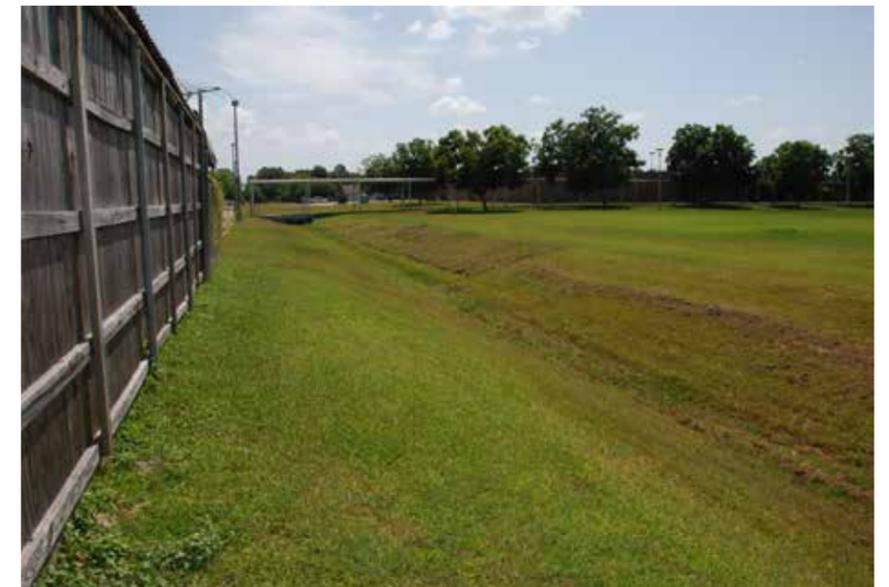
Figure 2: Drainage channel

The road crossing culverts, headwalls, and outfalls, are showing significant signs of degradation and should be remedied in the near future. A boundary and topographic survey would confirm the ownership of this channel (ACC, City, or CR3), and aid in the process of repair.
